***TMS320F280x, TMS320C280x, and
TMS320F2801x DSC***

Silicon Errata

Literature Number: SPRZ171J
December 2004–Revised February 2008

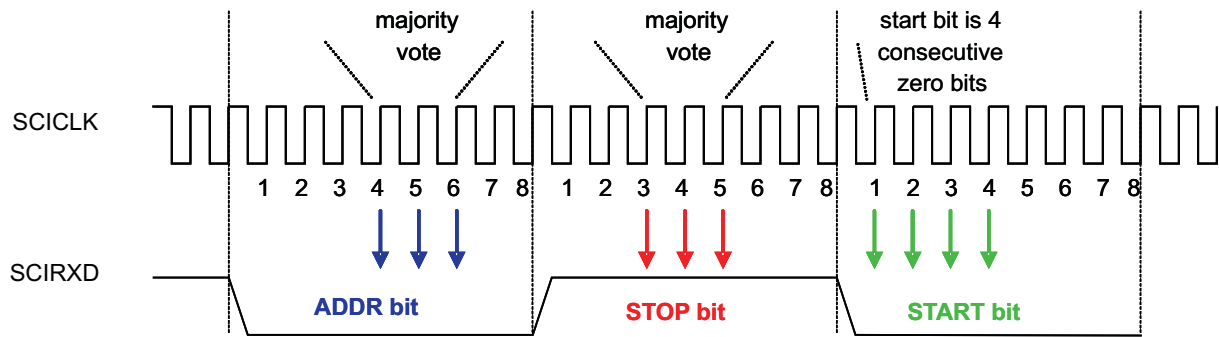
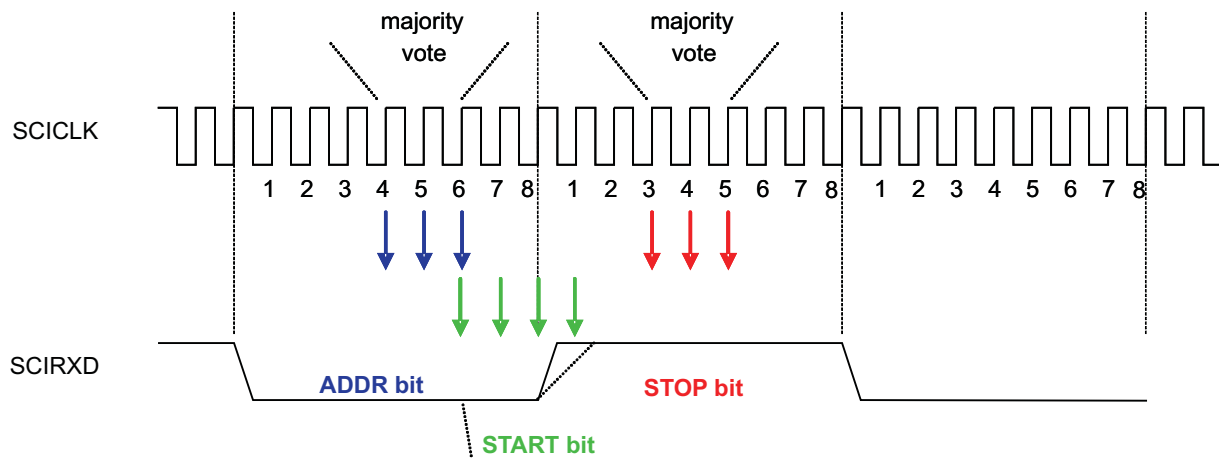
Figure 3. Difference Between Expected and Erroneous Operation of START Bit

Details SCI does not look for STOP bit after the ADDR bit. Instead, SCI starts looking for the start bit beginning on sub-sample 6 of the ADDR bit. Slow rise-time from ADDR to STOP bit can cause the false START bit to occur since the 4th sub-sample for the start bit may be sensed low.

Workaround(s) Program the baud rate of the SCI to be slightly slower than the actual. This will cause the 4th sub-sample of the false START bit to be delayed in time, and therefore occur more towards the middle of the STOP bit (away from the signal transition region). The amount of baud slowing needed depends on the rise-time of the signal in the system. Alternatively, IDLE mode of the SCI module may be used, if applicable.
